Mancos River Water Quality and Trends Assessment:

2011 – 2012

Prepared by Colin Larrick, Water Quality Specialist

Ute Mountain Ute Tribe

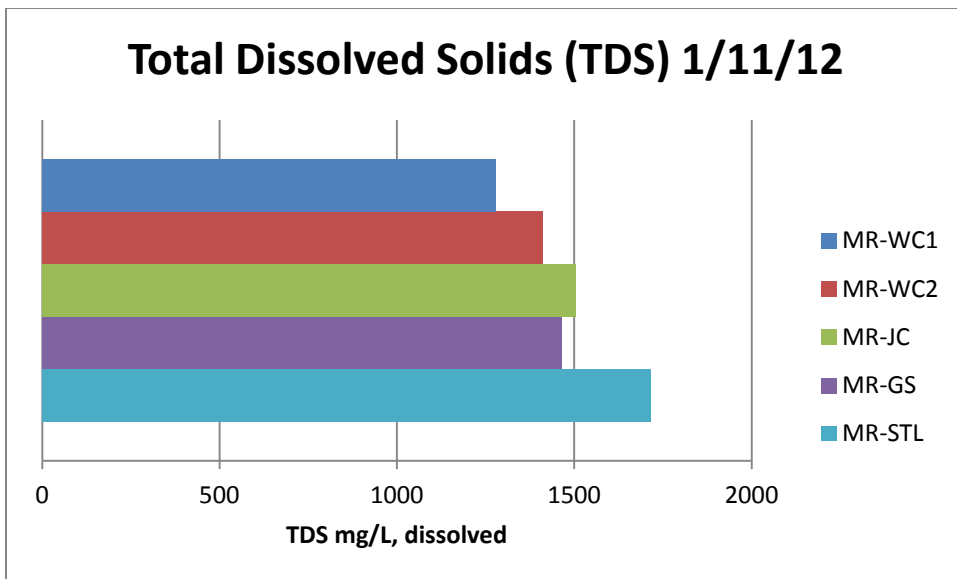
TDS and SAR for the May, 2012 (above) and January, 2012 sampling (below) events are displayed graphically showing increasing concentrations of ions from the upstream monitoring location, MR-WC1 to the downstream monitoring location, MR-STL.

TDS concentration in Weber Creek averaged approximately twice as high compared to the Mancos River at MR-WC1 (upstream of the confluence with Weber Creek). WC-MR (Weber Creek) averaged 2,090 mg/L and the Mancos River at MR-WC1 averaged 1,079 mg/L TDS during the sampling year (eleven measurements at each location).

For the Mancos River TDS values ranged from a maximum of 3,418 mg/L for the 5/16/2012 sample at MR-STL (furthest downstream site) to a minimum of 292 mg/L for the 4/10/2012 sample at MR-WC1 (furthest upstream site)

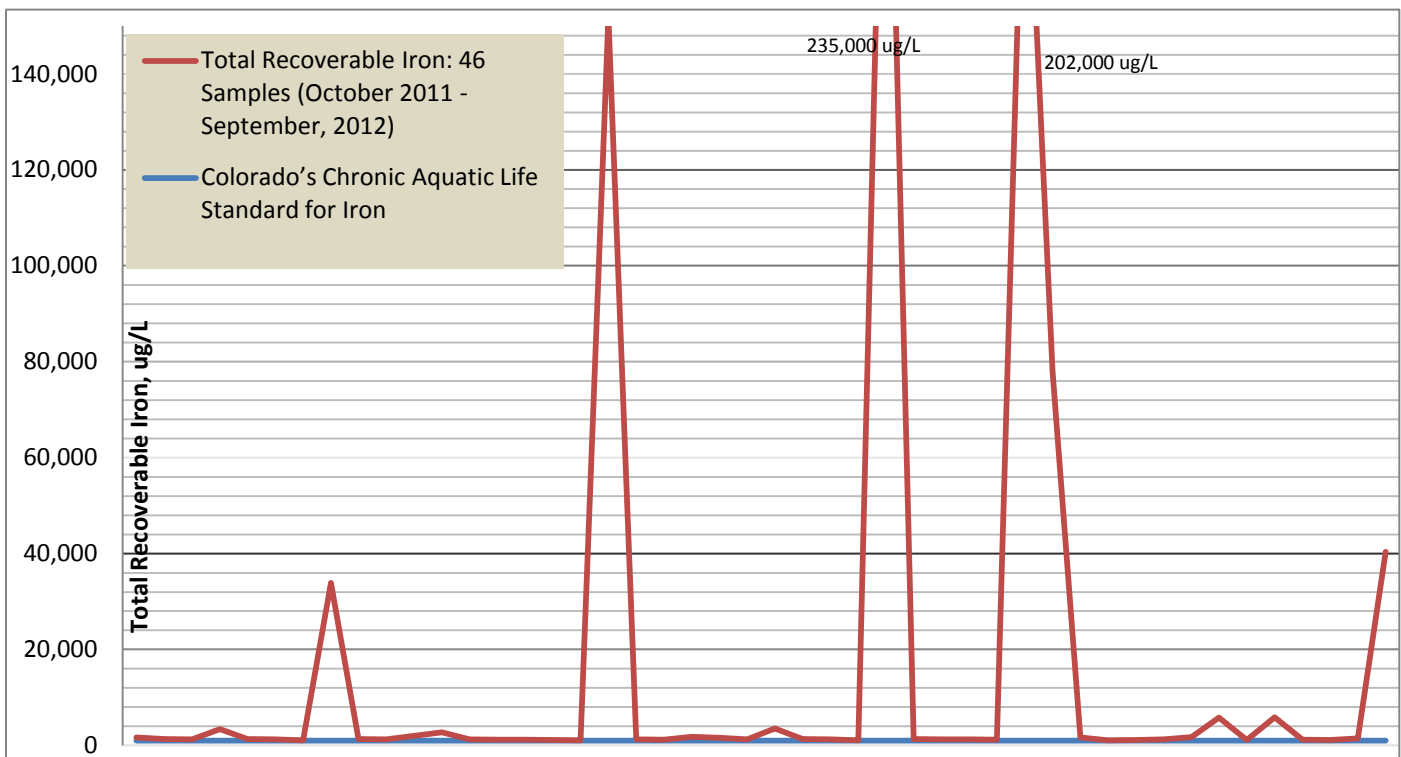
TOTAL IRON

The graph above illustrates iron concentrations in relation to Colorado's Chronic Aquatic Life Standard for Iron (1,000 ug/L total recoverable). Large peaks (above 20,000 ug/L) represent iron concentrations in post-fire flow events, discussed further in Section 4.0. Complete numeric iron results for all samples may be found in Table 3: Metals. The Tribe currently does not have a standard to

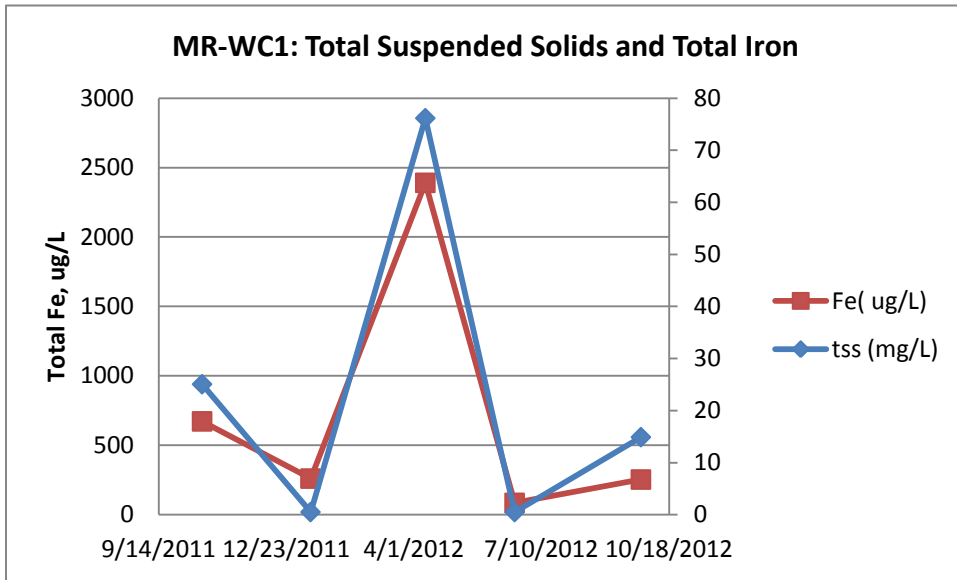
TOTAL SUSPENDED SOLIDS AND TOTAL IRON

The relationship between iron concentrations and suspended solids is also evident in the graph above for MR-WC1.

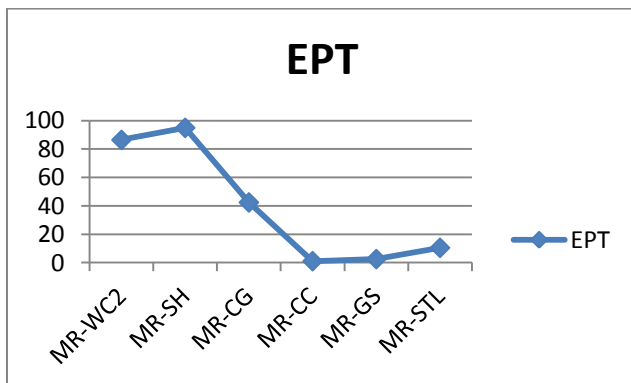
Ephemeroptera, plecoptera and tricoptera (EPT): EPT is a species composition and richness measurement. The three insect groups of Ephemeroptera (Mayfly), Plecoptera (Stonefly), and Tricoptera (Caddisfly) have been categorized as intolerant or sensitive to water quality. A high percentage score for EPT should correlate with good water quality (Mandaville, 2002). EPT numbers on the Mancos trended downward dramatically downstream.

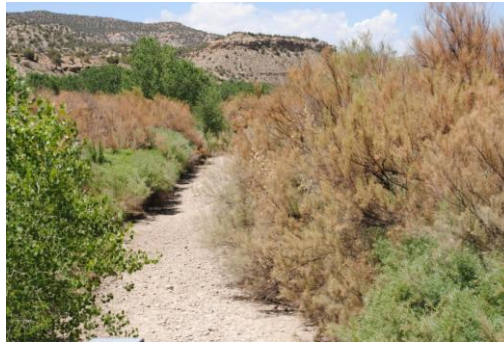
As graphically represented on the hydrograph for fiscal year 2012 (October, 2011 through September, 2012), the Mancos River was a dry channel and not flowing for an extended period from late May through mid-July and for shorter durations later in the summer (July/August/September in-between storm events).

The Mancos River runs dry each summer due to upstream agricultural diversions and partly due to widespread tamarisk infestation through the Canyon. Note- brown tamarisk has been defoliated by the tamarisk beetle. Summer, 2013.

Diversion structures upstream from the Reservation consume the entire flow of the Mancos River during these summer months as agricultural and domestic uses are appropriated by senior water right holders. The Tribe has recently been working towards developing a metered diversion structure for the Mancos Creek Farm. When the project is completed (the diversion structure currently needs to be re-built and a flow-gauge needs to be installed) which would allow the Tribe to exercise their water rights (1986 appropriation date) and make a call on the River to curtail junior users and provide flows to the diversion dam and to the farm. New instream flow appropriations are an additional tool that has been identified as a way to keep water in the channel (Mancos River Basin Instream Flow Report Preliminary Evaluation of Flow Restoration Options, Colorado Water Trust, 2011). Additionally, diversion and delivery system projects to increase efficiency, habitat restoration projects and phreatophyte eradication may help to restore and protect flows.

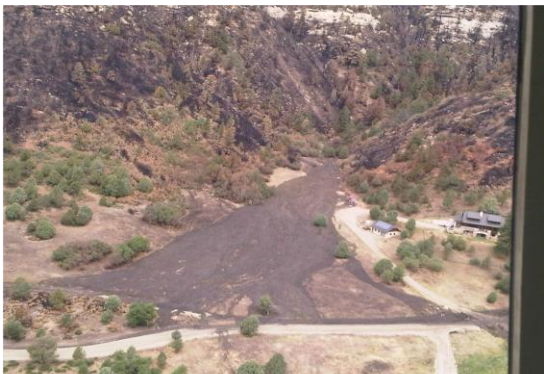
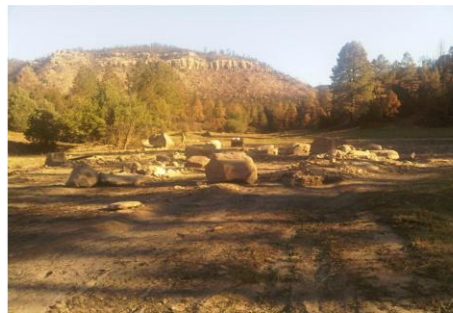
Great alluvial fan of ash in east canyon tributary shot from helicopter after first storm event on July 7th

Photographs above, provided by the BLM, illustrate the acceleration of overland flows and the amount of material that are mobilized following precipitation events in the areas burned during the Weber Fire.

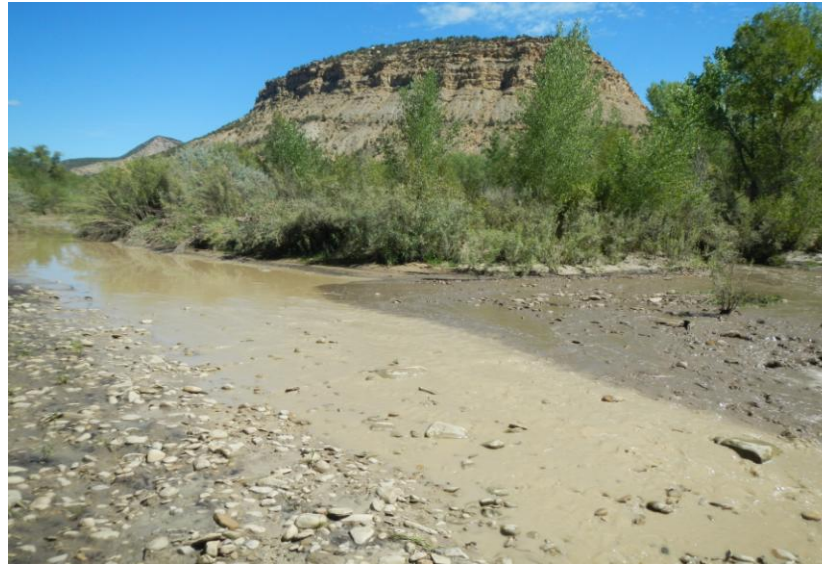
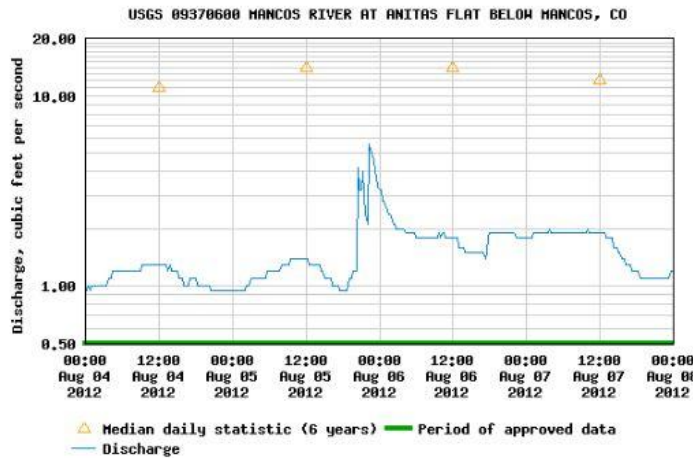
Post Fire Storm Flow (Small Precipitation Event, Low Flow)

Confluence, Mancos River, Weber Creek. August 06, 2012

Apparent in the information presented in the graphs above, storm event flows from the burned area of the Weber fire carry sediment into the River which corresponds to elevated levels of aluminum and iron along with metals: copper, manganese, zinc, and nutrients: nitrate/nitrite, total kjeldhal nitrogen and total phosphorus.

The prevalence of nitrogen in the organic form (Kjeldahl nitrogen) represents the influx of organic material (burned vegetation and organic material carried by overland flow) into the River. The lower dissolved oxygen numbers from the storm event flow are influenced by both the introduction of increased amounts of organic matter, in which dissolved oxygen in the River is consumed during the decomposition process, along with increased temperatures (colder water is capable of holding greater amounts of dissolved gas). The temperature increase is likely due to the increased solar absorption of the dark-colored water (see photographs of post-fire flows in the slide).

Graphs included on the following two pages present water chemistry data alongside precipitation and flow information for two sample events: August 6th, 2012 which is a sampling event affected by post-fire sediments carried into the river from a recent precipitation event; and September 26, 2012, a sampling event un-affected from post-fire sediment due to a lack of recent precipitation.

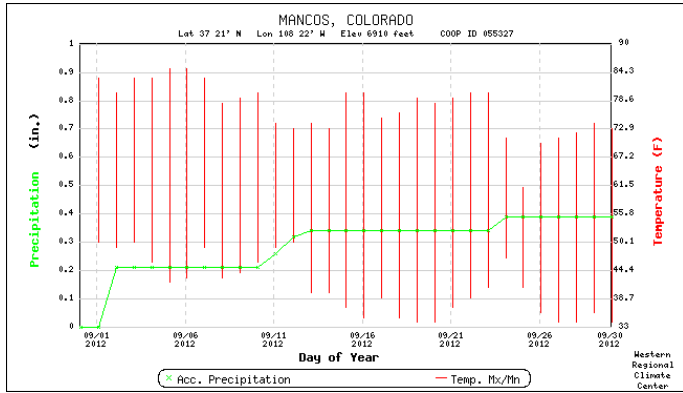
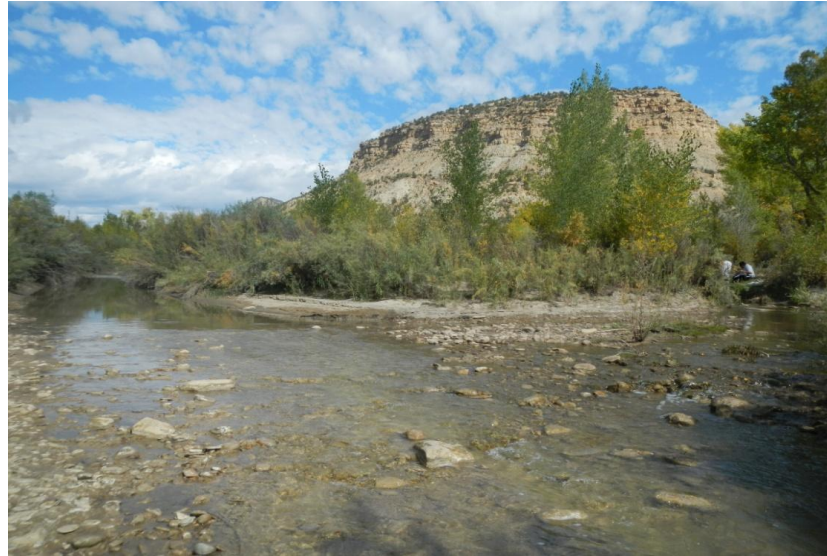
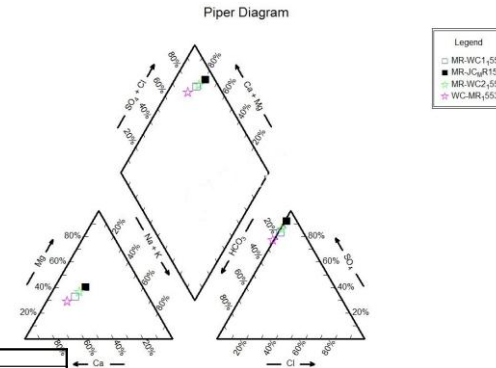
Post Fire Base Flow (No Recent Precipitation Event, Low Flow)

Confluence, Mancos River, Weber Creek. September 26, 2012
